**SECOND FIVE-YEAR REVIEW REPORT FOR
TAYLOR LUMBER AND TREATING SUPERFUND SITE
YAMHILL COUNTY, OREGON**

May 2017

**U.S. Environmental Protection Agency
Region 10
Seattle, Washington**

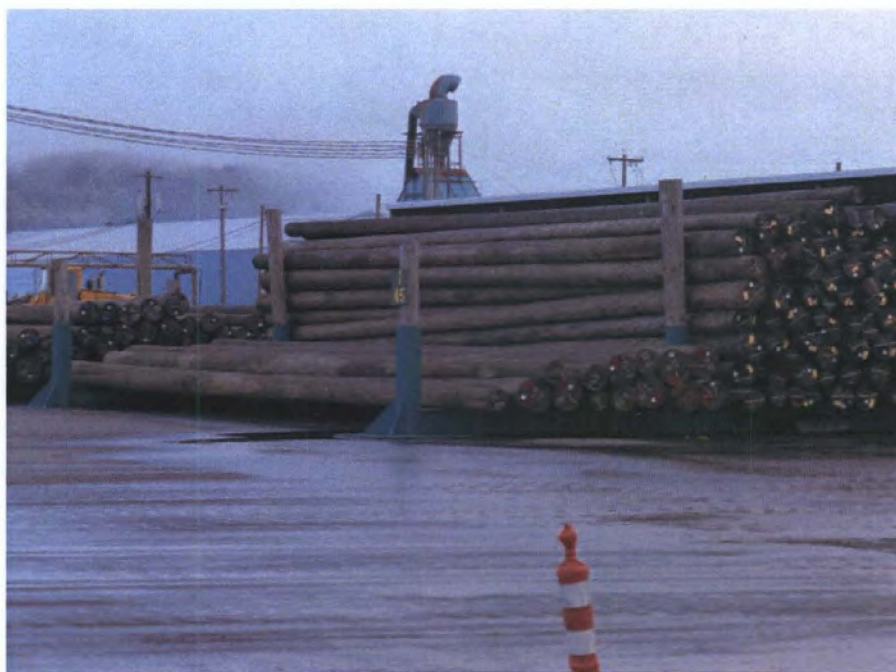
Bunk storage system.

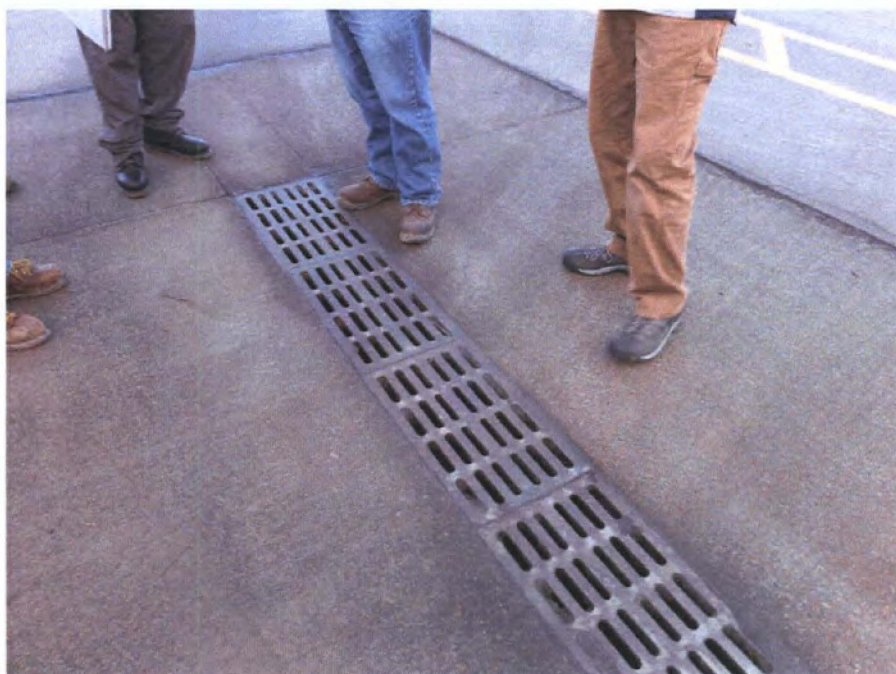
Stormwater capture drain.

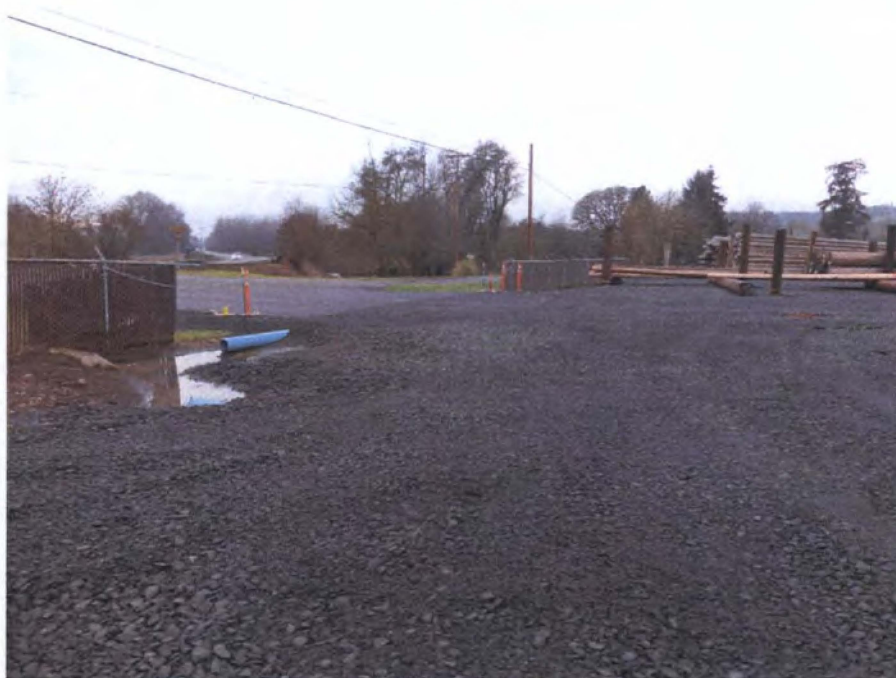
New truck entrance.

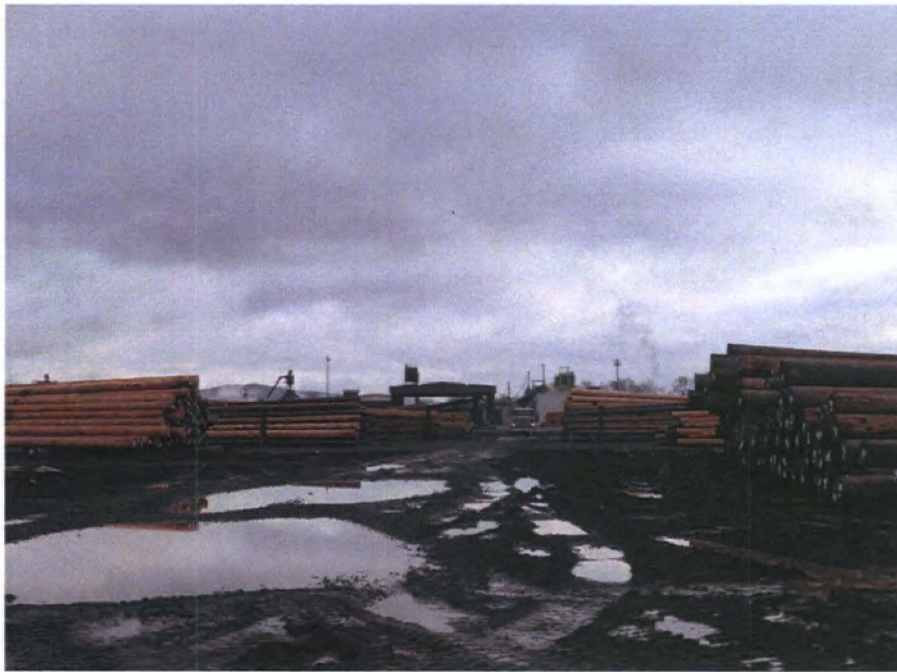
East-facing view of timber storage.

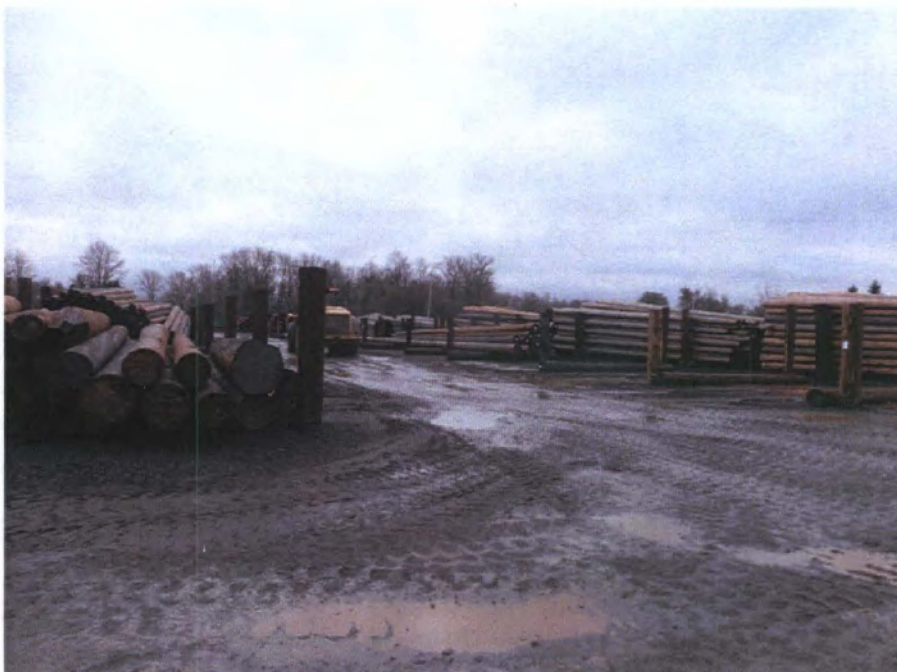
Division of untreated and treated timber storage.

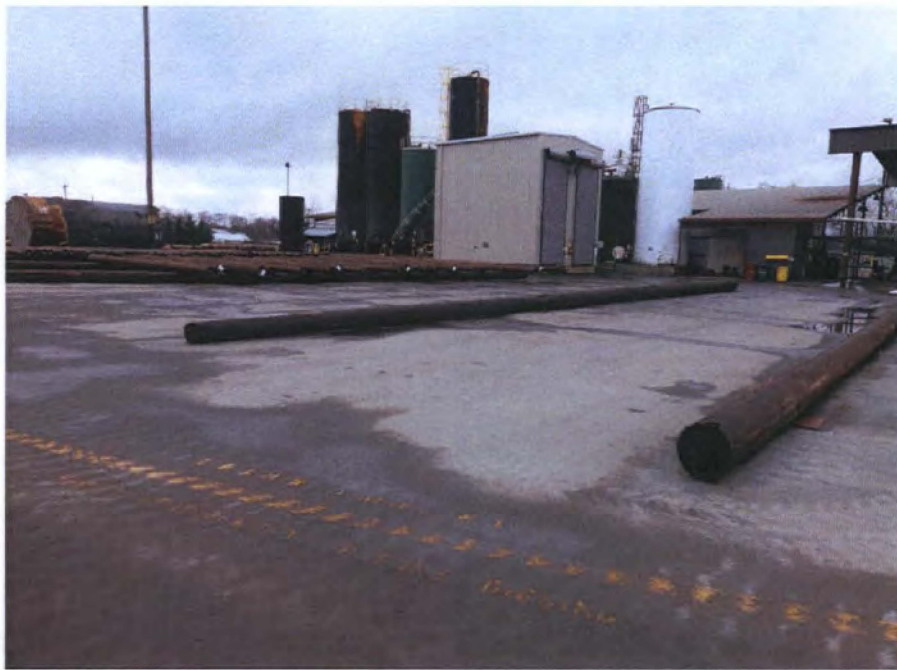
Edge of MatCon cap, marked with yellow paint.

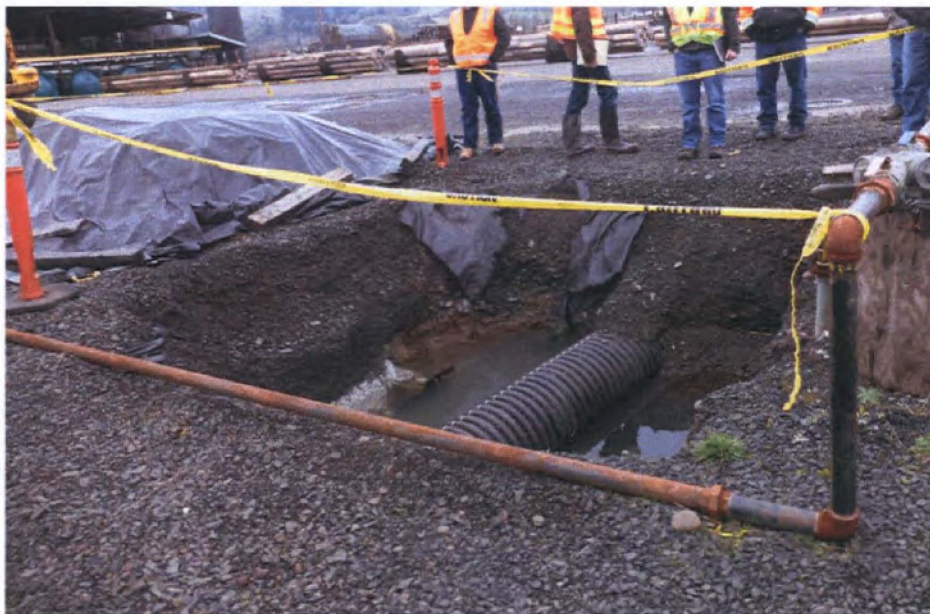
Area outside cap under construction.
Leaking water line replacement.

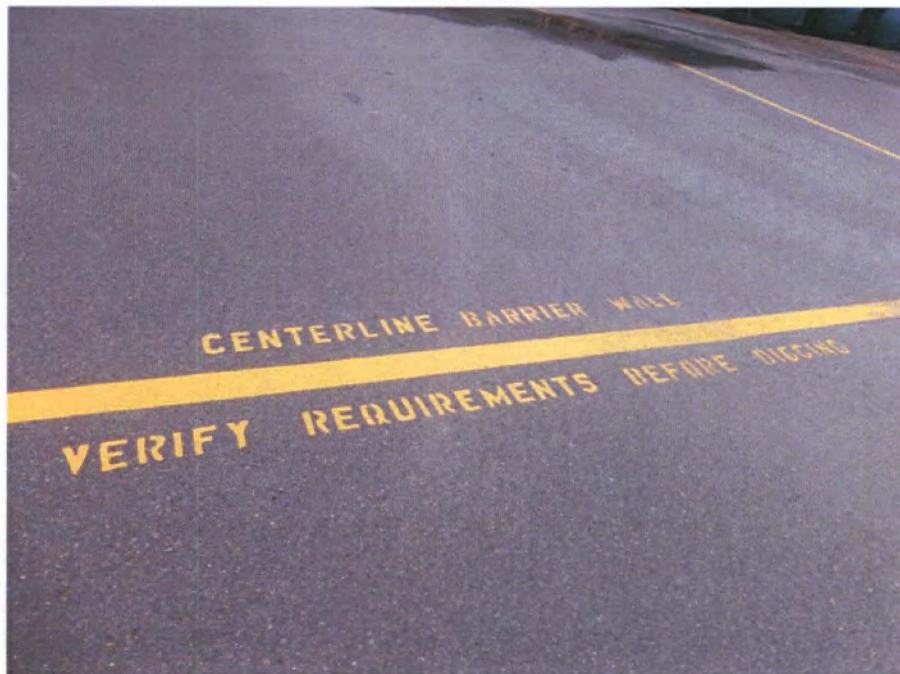
Paint indicating centerline of barrier wall.

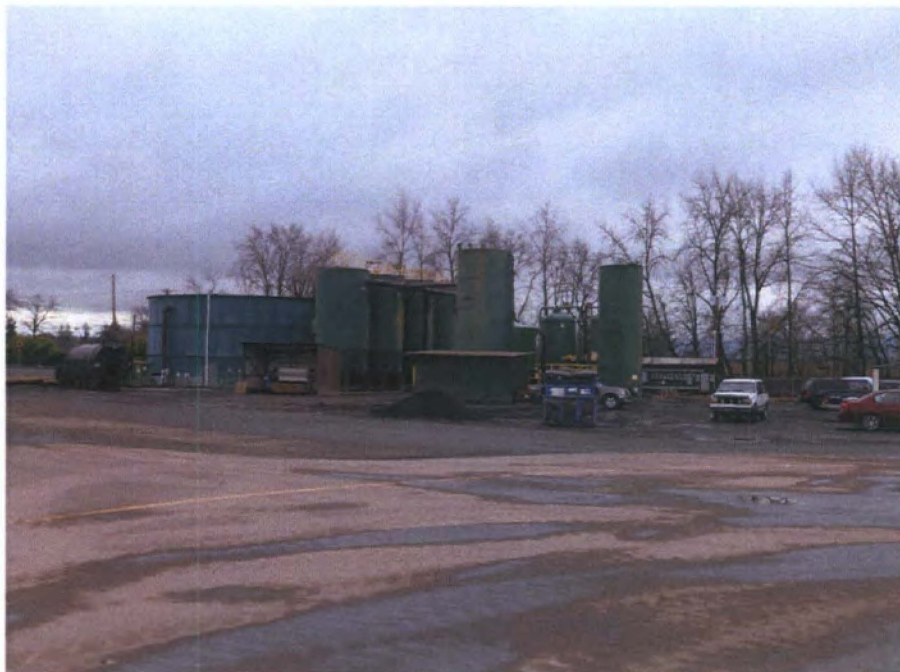
Stormwater treatment system.
